nmonastery

heated in the brisk Piedmont winter, to be properly air ed in the brutal, humid summers of North Carolina, sufom lack of bathroom facilities, old plumbing and unsafe by and health regulations were the combined factors which led vation of the monastery at Belmont Abbey. year old structure was in bad physical condition so the

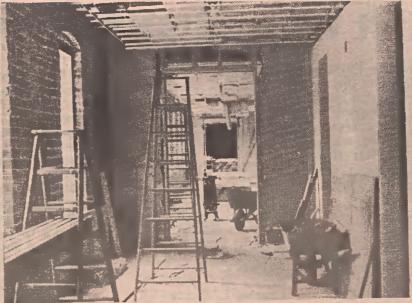
WHILE WORK WAS in progress, all ceilings and the entire interior was torn out except for weight supporting walls

terior walls were torn out," explained Fr. Peter Stragand, rior, "except the brick walls that were weight-bearing. The except for the beams, were also removed. The building was down as far as you could go.

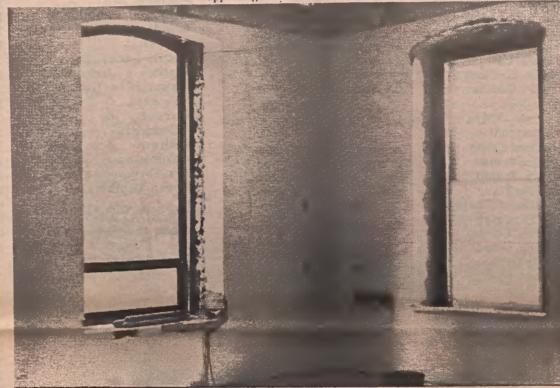
TWO DIFFERENT WINDOWS - At left is the new pane and the right is one of the older windows that was later removed.

onks, who began moving into the monastery in mid-January, e new thermal polarized windows, a new heating system and litioning.

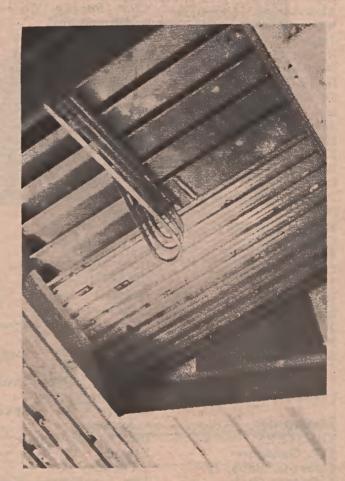
ALL THE HAZARDOUS wooden stairs were replaced by concrete and metal, fire-proof stairs like these.

changes include the size of the chapel, which was cut almost ecause now only Mass is celebrated there with the sick. All votions are in the Abbey church. The infirmary area was 1; concrete and metal stairs were installed at both ends of astery from the third floor down to the basement for fire regulations; a library was built on the second floor isly, there was no library in the monastery); television nd reading rooms were separated; work rooms and a storage the third floor have been converted into bathrooms; ms have been added on the first two floors; a new ceiling and e floor were added to the basement.
